## Electrical Technician Electrocuted after Contacting a 800-volt Conductor in South Carolina

### SUMMARY

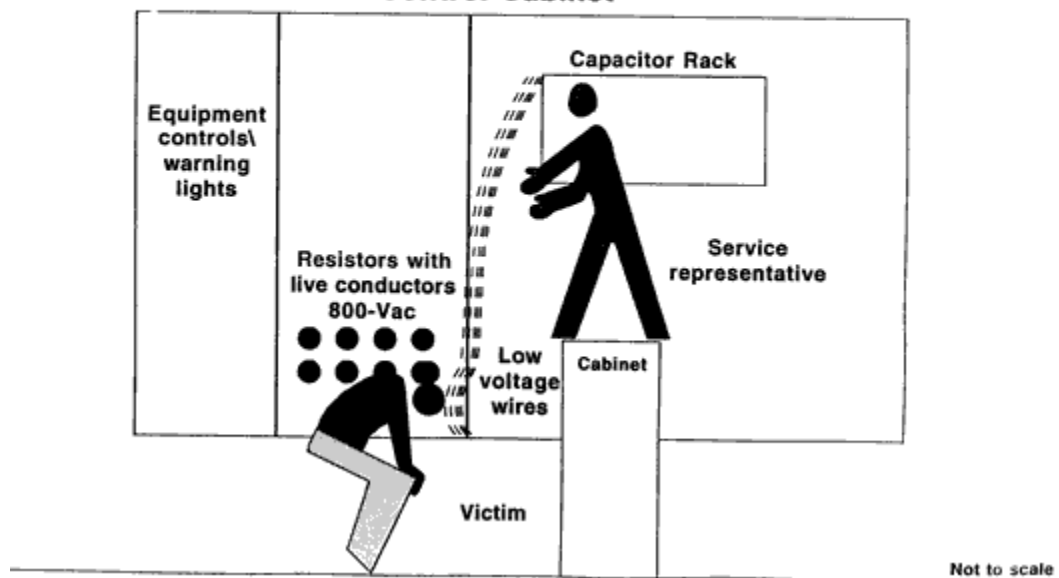
*Figure. Mini-Comp System*

mill. On the day of the incident, the victim had been instructed to meet with and assist a service representative from the company that manufactured a piece of voltage regulating equipment. The equipment (a Mini-Comp system) was being used to control voltage surges and regulate voltages to different pieces of equipment throughout the plant ([Figure](#)).

At that time the victim returned, kneeled in front of the opened control cabinet, and positioned his head and shoulders inside the 800-volt resistor compartment. As he began tugging on the wires inside the compartment, he was told by the service representative to be careful around the conductors. The service representative was watching to see which wire moved when he heard the victim making a gurgling noise. When he looked down he saw the victim shaking as though he were being shocked. He jumped down from the cabinet and although receiving a shock himself, knocked the victim away from contact with the energized conductor.

**Discussion:** The victim was in the process of trying to identify non-color-coded wiring in the regulating unit when he contacted an energized conductor and was electrocuted. Color-coded insulation covering the wiring is unique to specific conductors, and can be readily identified and separated from all others in the same wiring harness or conduit. Voltage regulating equipment should be designed and manufactured with unique color-coded conductors for each separate circuit in the cabinet or compartment of electrical equipment. Also, electrical equipment purchase orders should require voltage regulating equipment conductors be color-coded, and electrical equipment deliveries should be inspected for compliance before delivery acceptance and before equipment installation.

***Recommendation #3: Voltage regulating equipment should be wired with color-coded conductors.***
