## Electrician Apprentice Dies Following a 33-foot Fall Through a Roof--South Carolina

### SUMMARY

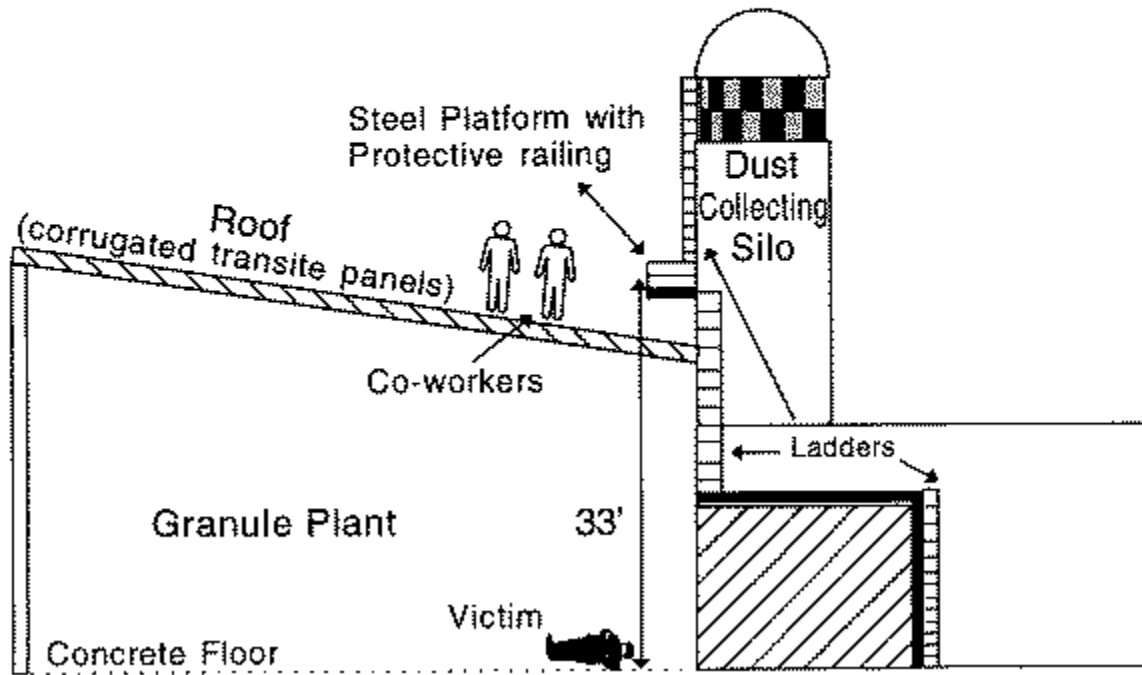
*Figure.*

The employer had been contracted by a roofing products manufacturer to install electrical conduit, wiring, and related components at the dust-collecting silo located in the granule plant. The silo was situated adjacent to and partially above the roof of the 29-year-old granule plant. The plant walls and roof were constructed of corrugated transite panels, a fire-proofing material used in walls and roofs and for lining ovens. The panels were composed of asbestos and cement molded under high pressure, and they had a load rating of 200 pounds per square foot. The panels were set in place on steel girders approximately 30-inches apart. Work on the dust-collecting silo had been in progress for 3 days before the incident.

On the day of the incident, the victim and four co-workers (one foreman, and three other electrician apprentices), arrived at the plant and started work at 7 a.m. The workers had spent the morning installing the necessary conduit and pulling electrical wire through it. At approximately 11:35 a.m., the workers were getting ready to break for lunch. The victim had just completed pulling electrical wire through a conduit while standing on a steel platform attached to the side of the silo. The platform was equipped with a standard protective steel railing which consisted of a top rail, mid rail, and toe board. The granule plant roof was directly below the platform, approximately 34 inches from the mid rail ([Figure](#)). The foreman and another worker were standing on the granule plant roof about 10 feet from the edge of the platform, waiting for the victim to finish his task and go to lunch. Plant personnel had seen the workers using the roof as a route of access to the ladder leading to the ground. His back toward the other workers, the victim climbed over the top rail, and with his feet resting on the mid rail, jumped to the granule plant roof. The victim, who weighed 235 pounds, broke through the corrugated transite panels and fell to the concrete floor 33 feet below. An employee working in the granule plant saw the victim fall and strike the concrete floor. The employee and the workers from the roof ran to aid the victim, who suffered a severe head injury. The victim was unconscious and was not breathing. Cardio Pulmonary Resuscitation (CPR) was started and the EMS was called. The Emergency Medical Squad (EMS) arrived in less than 15 minutes and pronounced the victim dead at 11:50 a.m. The medical examiner arrived on the scene shortly thereafter and had the victim transported to the morgue at the local hospital.

Discussion: Owners of plants/facilities where outside contractors perform jobs should work with contractors to identify areas that may be hazardous. After these areas have been identified, signs and/or barriers, along with verbal communication with the contractors, should be established. Additionally, if work must be performed in one of the identified hazardous areas, appropriate precautions and procedures should be implemented and enforced. [Note: Since this incident, the roofing manufacturer has instituted a safety procedure prohibiting any access to the roofs without the use of a safety belt, lanyard, and lifeline.]
