## Electrician Apprentice Electrocuted after Contacting a 480-volt Conductor in South Carolina

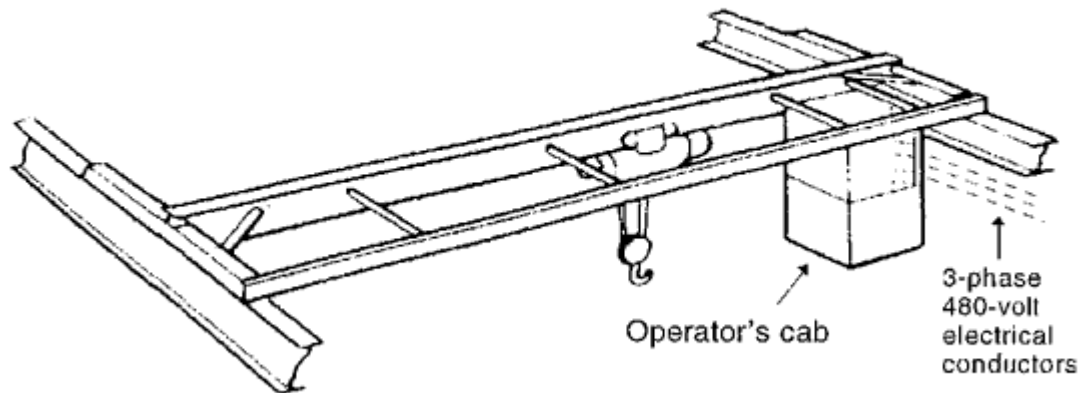
*Figure. Overhead Cab-operated Crane*

Power for the cranes was provided, via collector leads, by a three-phase, 480-volt circuit composed of three bare steel contact conductors which ran adjacent to the operator's cab/crane bridge ([Figure](#)) for the entire length of the building.

platforms to remove the likelihood of approach or contact by persons or objects to a point of danger." The crane runway conductors were not guarded when this incident occurred. [Note: Subsequent to the incident, metal screen guards were welded around the operator's cab/bridge area that is in proximity to the contact conductors.]

**Discussion:** This article states that "Runway contact conductors shall be guarded, and bridge contact conductors shall be located or guarded in a manner that persons cannot inadvertently touch energized current-carrying parts." The National Electrical Code defines guarded as "covered, shielded, fenced, enclosed, or otherwise protected by means of suitable covers, casings, barriers, rails, screens, mats, or
