## **Electrician Electrocuted After Contacting Energized Conductor While Working From the Bucket of an Aerial Lift Truck--Virginia**

### **SUMMARY**

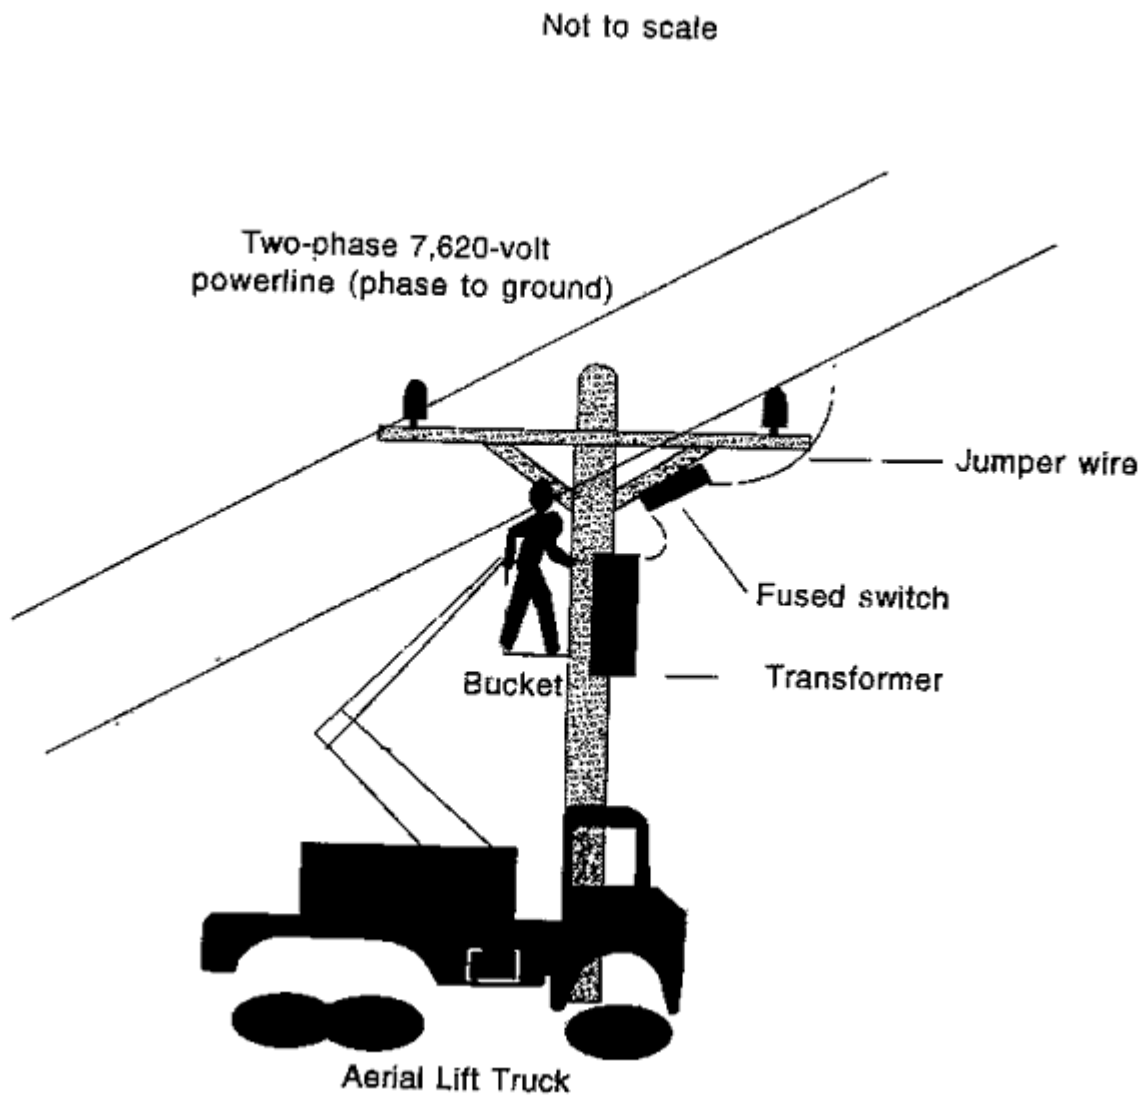
continue replacing switches. Five switches had been replaced the day before and work was to be performed on the sixth switch. It was determined that the victim would work from the bucket of the aerial lift truck (a double bucket Pitman Uni/dyne aerial lift mounted on a 1982 GMC Truck) while he replaced the switches and the co-worker would remain on the ground performing other tasks. The victim positioned himself in the bucket and maneuvered the bucket adjacent to the powerline in proximity to the switch. He used a "hot stick" to disconnect the jumper wire from the switch to the powerline, stopping the flow of electricity from the powerline to the switch and transformer. Without donning personal protective equipment (PPE) or covering the powerlines with insulating line sleeves or blankets, he removed one of the bolts securing the switch to the crossarm as the co-worker watched from the ground. At that time the company owner arrived and began a conversation with the co-worker. As the victim either began to remove another bolt or tried to reposition the bucket, he contacted the powerline ([Figure](#)). While the owner and co-worker were talking, they heard an arcing and popping sound, and looked up to see the victim slump down into the bucket. The company owner immediately jumped onto the truck and used the controls mounted on the pedestal to lower the bucket while the co-worker called 911 for assistance. The paramedics arrived within 6 minutes and determined the victim had died. The medical examiner was notified and he directed the paramedics to transport the body to a local mortuary.

*Figure. Worker Contacting Overhead Powerline*

***Recommendation #1: Employers should require that workers wear appropriate personal protective equipment when they are exposed to hazardous conditions and ensure that energized powerlines are insulated or guarded before work is performed on or near them.***

**Discussion:** 29 CFR 1926.28 (a) states "The employer is responsible for requiring the wearing of appropriate personal protective equipment in all operations where there is an exposure to hazardous conditions or where this part indicates the need for using such equipment to reduce the hazards to the employees." Also, 29 CFR 1926.950 (c)(1)(ii) states "The energized part is insulated or guarded from him and any other conductive object at a different potential." Work was being performed from an aerial lift truck bucket near energized, unguarded or insulated powerlines and appropriate PPE was not being worn. The rubber gloves, sleeves, and line hoses used for this type of work were later found in the aerial bucket and bins of the truck.
