# Fatality Assessment and Control Evaluation (FACE) Program

## Licensed Electrician Dies When Electrocuted by 480 Volts

Kentucky  
Case  
Report:  
03KY115

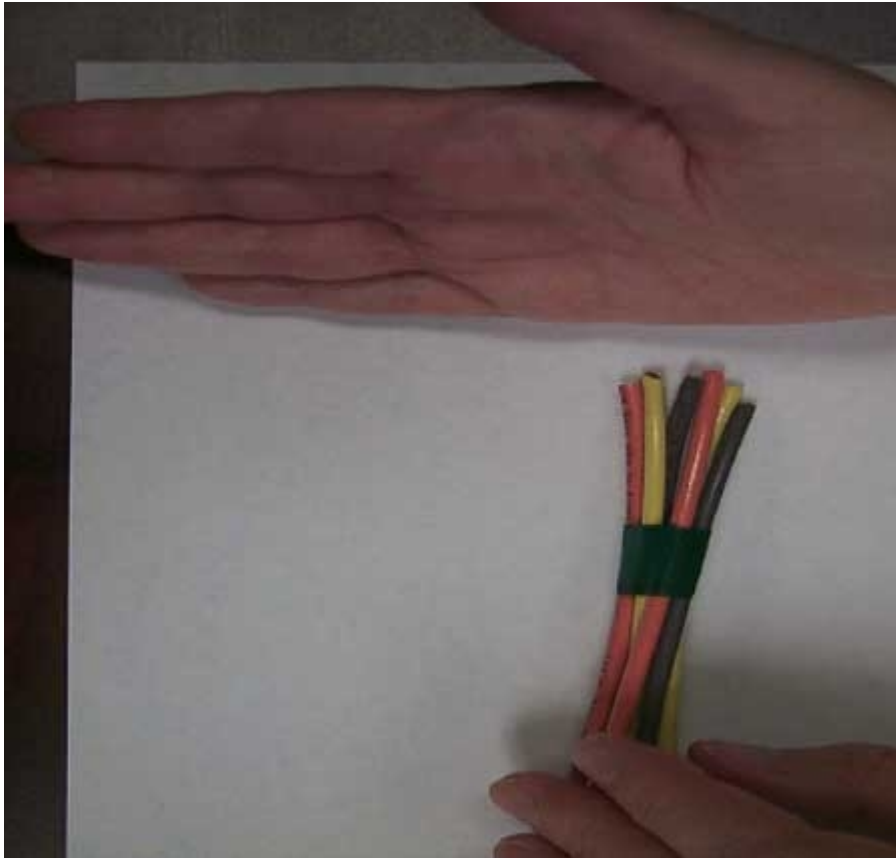
**An example of wires lead electrician was taping in his palm when he was electrocuted.**
